29 PRESERVATION BRIEFS

The Repair, Replacement, and Maintenance of Historic Slate Roofs

Jeffrey S. Levine

U.S. Department of the Interior
National Park Service
Cultural Resources
Heritage Preservation Services

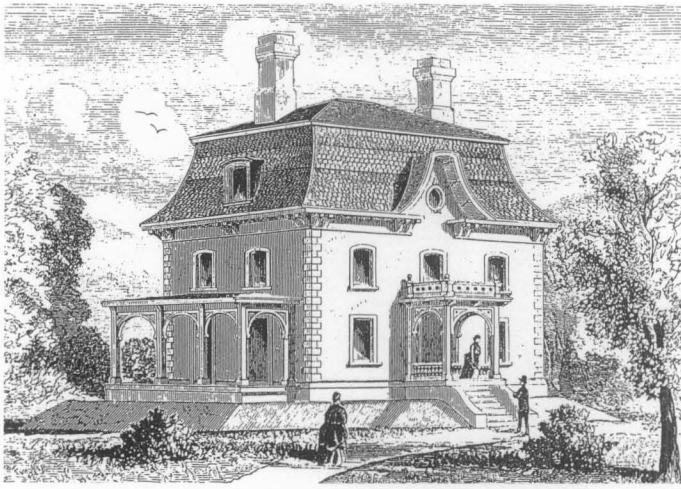
Figure 1. Architectural pattern books of the mid-nineteenth century awakened Americans to the availability and quality of slate for roofing purposes by incorporating slate roofs in their designs. Design XX, "A French Roof House," in A. J. Downing's *Victorian Cottage Residences* is shown.

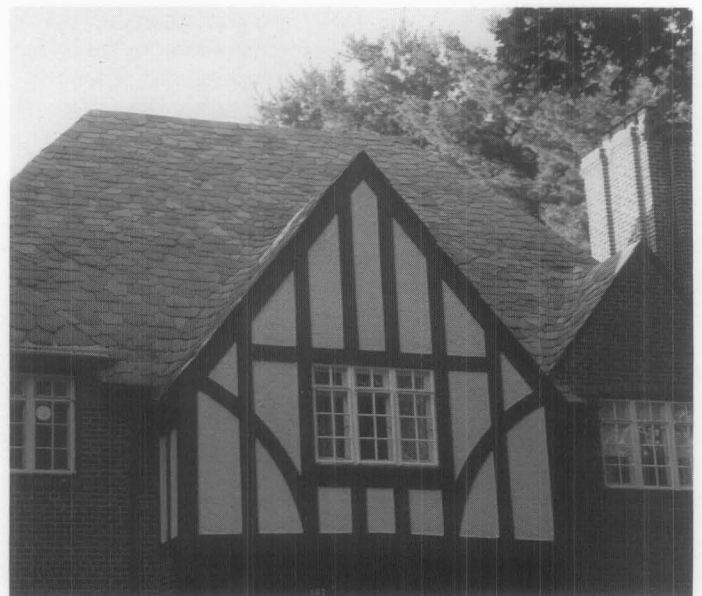
Figure 2. The quaint character of this Tudor style residence is derived, in part, from its textural roof.

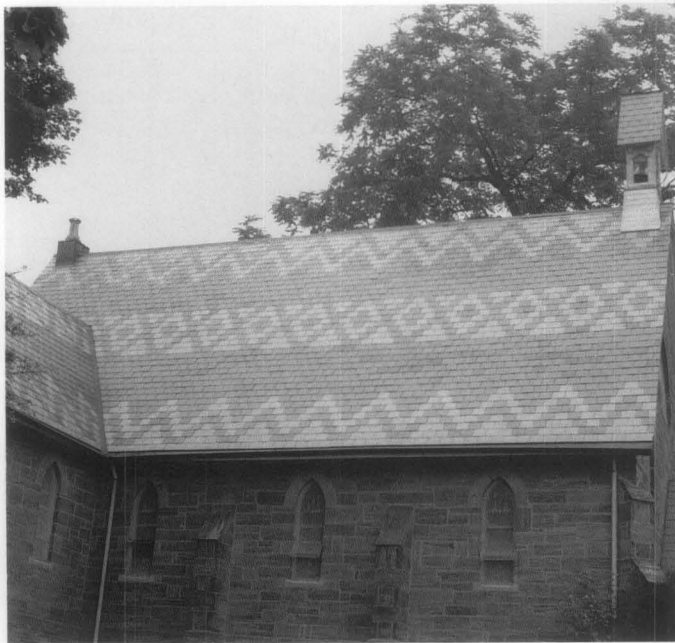
Figure 3. A sawtooth geometric design composed of red, green, and black slates makes this roof the most visually important feature of the building.

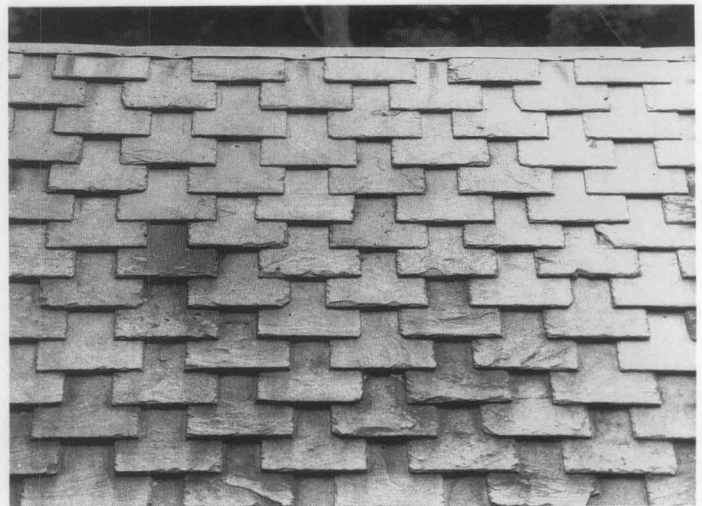
Figure 4. Widely spaced open slating was often used on utilitarian structures where ventilation was desirable. It provided an interesting texture and visual pattern to often plain structures.

Historically, three types of slate roofing—standard, textural, and graduated—were available according to the architectural effect desired. Standard grade slate roofs were most common. These are characterized by their uniform appearance, being composed of slates approximately 3/16" (0.5cm) thick, of consistent length and width, and having a smooth cleavage surface. Thirty different standard sizes were available, ranging from 10" (25cm) × 6" to 24" × 14" (15cm × 61cm × 35cm). The slates were laid to break joints and typically had square ends and uniform color and exposure. Patterned and polychromatic roofs were created by laying standard slates of different colors and shapes on the roof in such a way as to create sunbursts, flowers, sawtooth and geometric designs, and even initials and dates (Figure 3). On utilitarian structures, such as barns and sheds, large gaps were sometimes left between each slate within a given course to reduce material and installation costs and provide added ventilation for the interior (Figure 4).

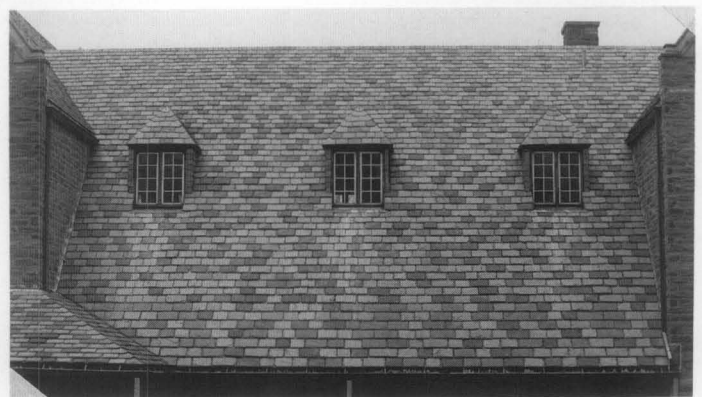
Figure 5. This graduated slate roof is composed of large, thick slates at the eave which are reduced in size and thickness as the slating progresses to the ridge.

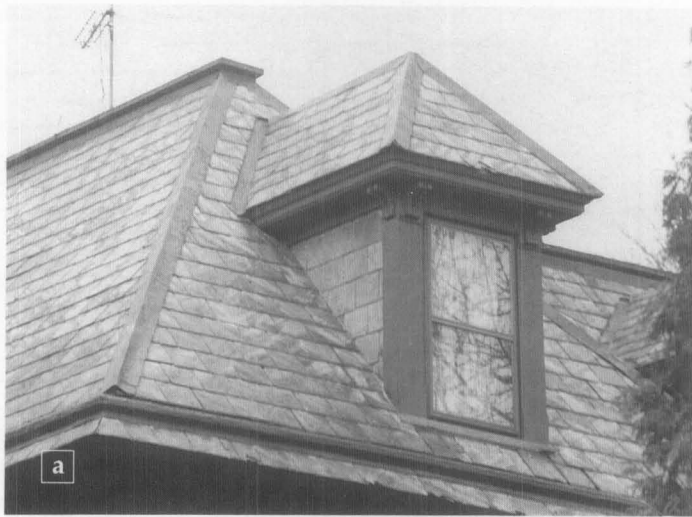
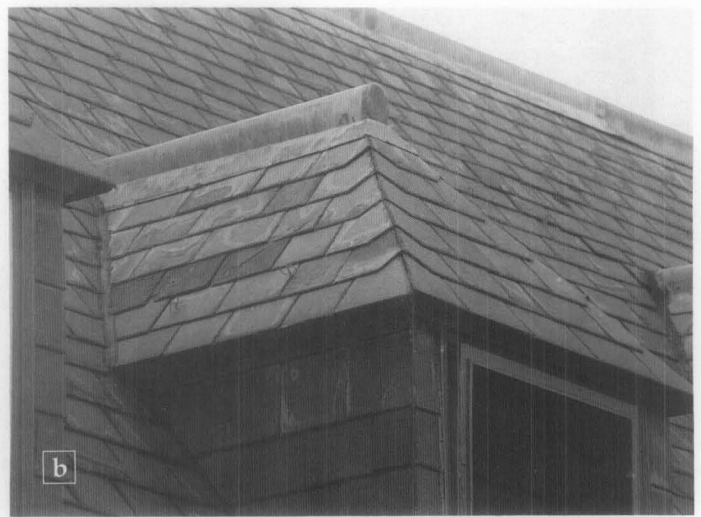
Figure 6. Hips are formed at the external angle of two roofing slopes. In (a), the hips at both the roof and the dormer are covered with metal. Note also the open valley and the built-in gutter. In (b), the dormer hip slates have been laid in a fantail pattern to help shed water. Note also the metal ridge cap.

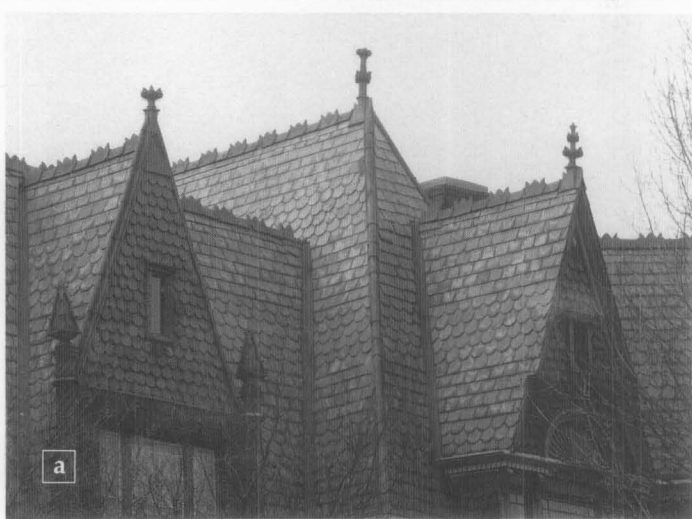
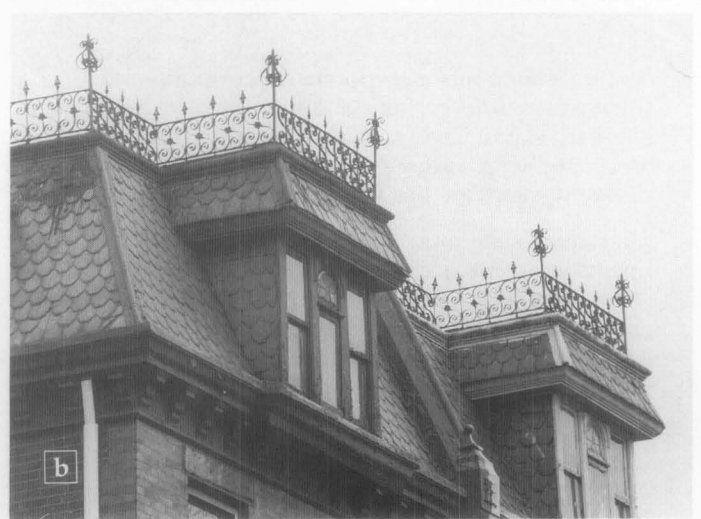
Figure 7. Ridge caps and cresting can be elaborate. Ridges are formed at the long horizontal juncture of two roofing slopes and capping protects this joint from moisture. In (a), a terra cotta capping with a decorative profile complements the finial over the various roof peaks. In (b), the mansard roof has a decorative iron cresting at the break between the lower and the upper roof slopes.

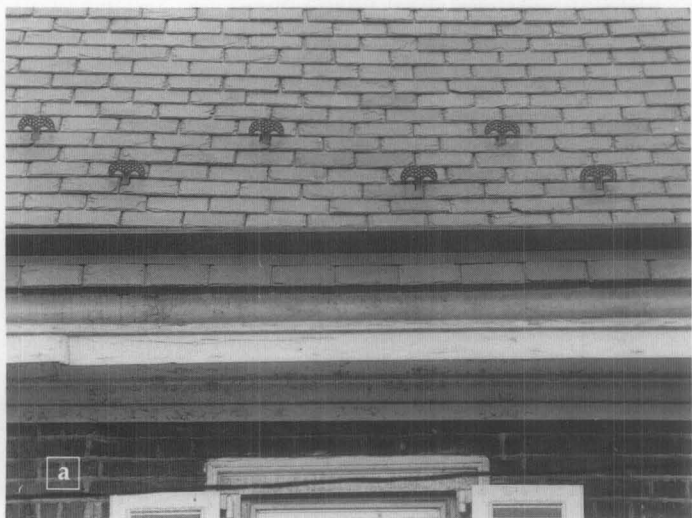
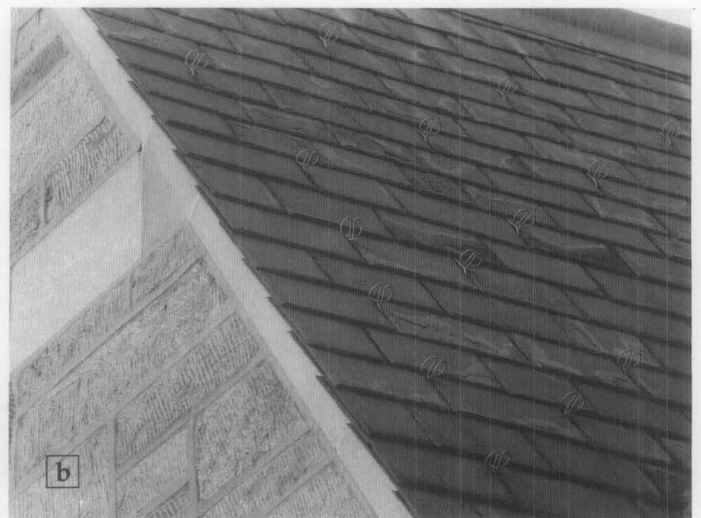
Figure 8. Eave details include snow guards, snow boards, gutter treatments. Snow guards are generally used in areas where ice and snow accumulate to avoid dangerous slides from the roof. In (a) the snow guards are set in two staggered rows above a pole gutter. In (b), the copper wire snow guards are set more frequently up a very steep gable.

Detailing at the hips, ridges and valleys provided added opportunity to ornament a slate roof. Hips and ridges can be fashioned out of slate according to various traditional schemes whereby the slates are cut and overlapped to produce a watertight joint of the desired artistic effect. Traditional slate ridge details are the saddle ridge, strip saddle ridge, and comb ridge, and for hips, the saddle hip, mitered hip, Boston hip, and fantail hip (Figure 6). A more linear effect was achieved by covering the ridges and hips with flashing called "cresting" or "ridge roll" formed out of sheet metal, terra cotta, or even slate (Figure 7). Snow guards, snow boards, and various types of gutter and rake treatments also contributed to the character of historic slate roofs (Figure 8).

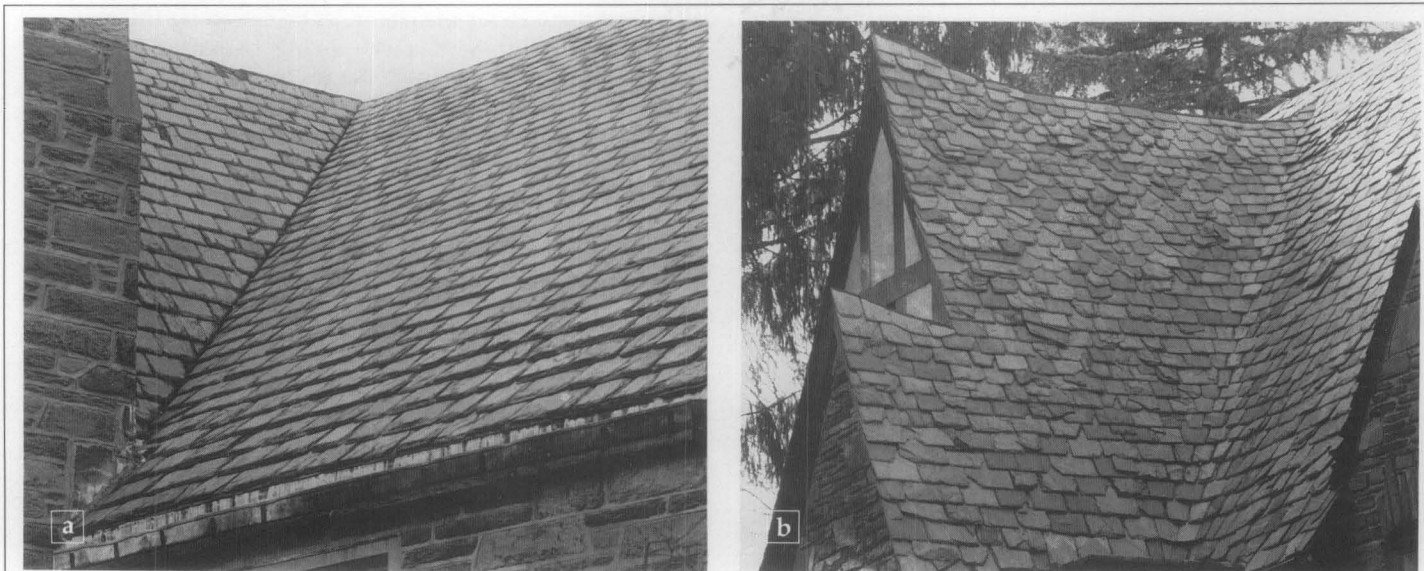
Figure 9. Valleys are formed at the internal angle of two roofing slopes. Flashing is often placed under the slate to increase moisture protect at this vulnerable joint. Shown in (a) is a closed valley where the slates are held tight to the valley line. (b) illustrates of a round valley where the transition between the two slopes is a continuous curve. It requires careful workmanship and an experienced roofer.

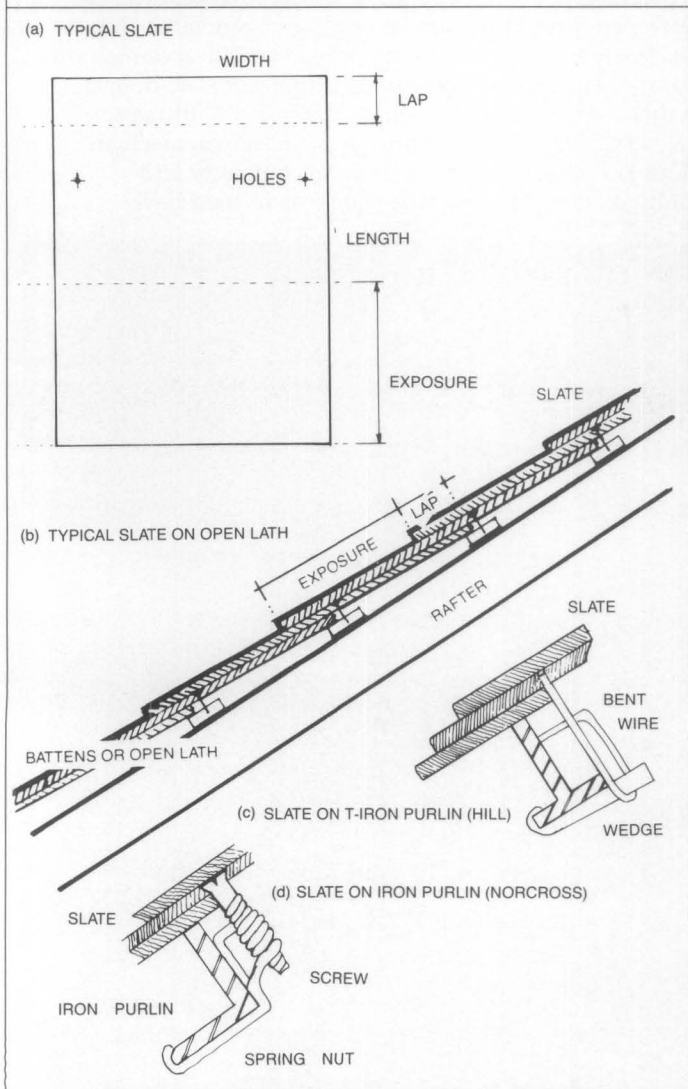
Figure 10. (a) shows a typical slate; exposure may be calculated by subtracting the headlap from the total length of the slate and dividing by two. Slates were typically nailed either to closed wooden decking or to open laths (b). In the late 19th century, with the concern for fireproof construction, special fasteners were developed to secure slate to steel purlins (c) 1881 patent to James G. Hill; (d) 1889 patent to Orlando W. Norcross).

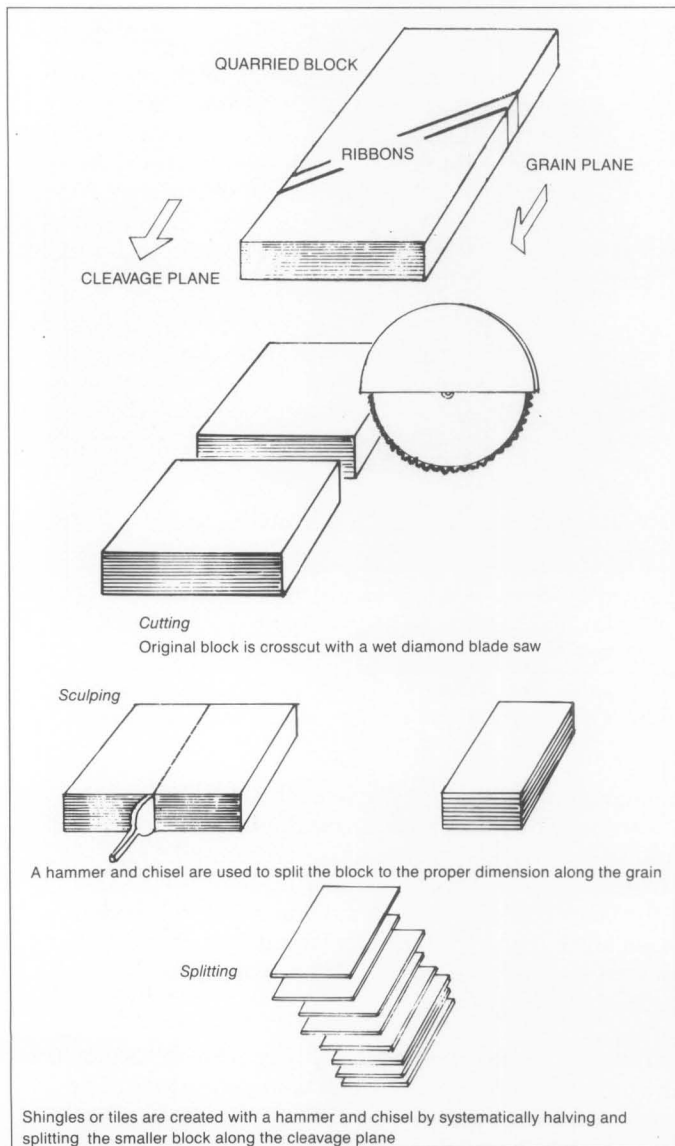
Figure 11. Slate roofing tiles or shingles are still manufactured using traditional methods brought to this country by Welsh immigrants in the nineteenth century. Shown above are the first 3 steps of cutting, sculping and splitting. Once the rough slate tile is made it is trimmed and punched for holes.

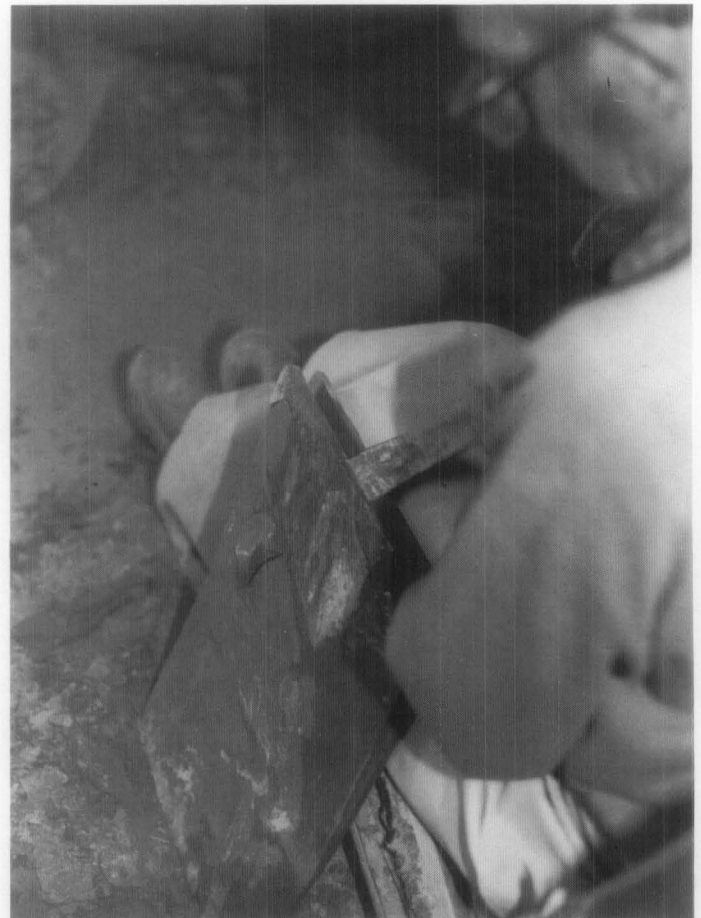
Figure 12. In the splitting area, the slightly oversized blocks are split along their cleavage planes. The splitter's tools consist of a wooden mallet and splitting chisels. The process of halving the split portions is repeated until a tile or shingle of appropriate thinness is obtained.

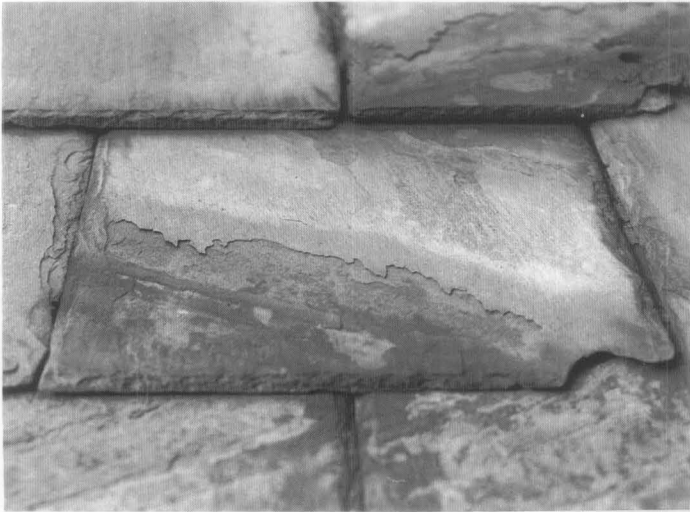
Figure 13. Paper thin lamination can be seen flaking off of this weathered, 120 year piece of Pennsylvania Hard-Vein slate.

The natural weathering of roofing slate manifests itself as a slow process of chipping and scaling along the cleavage planes (Figure 13). Paper thin laminations flake off the surface of the slate and the slate becomes soft and spongy as the inner layers begin to come apart, or delaminate. The nature of the sound given off by a slate when tapped with one's knuckles or slating hammer is a fair indication of its condition. High-grade slate, when poised upon the fingertips and struck, will emit a clear, solid sound. Severely weathered slates are much less sonorous, and give off a dull thud when tapped.

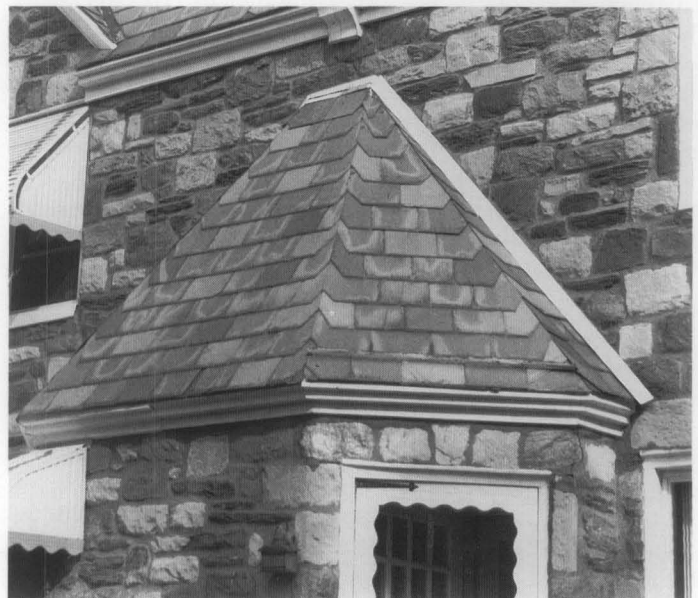
Figure 14. The white blotches on these Pennsylvania Soft-Vein slates indicate areas where gypsum is leaching out onto the surface of the slates.

The weathering of slate is chiefly due to mineral impurities (primarily calcite and iron sulfides) in the slate which, in concert with alternating wet/dry and hot/cold cycles, react to form gypsum (Figure 14). Because gypsum

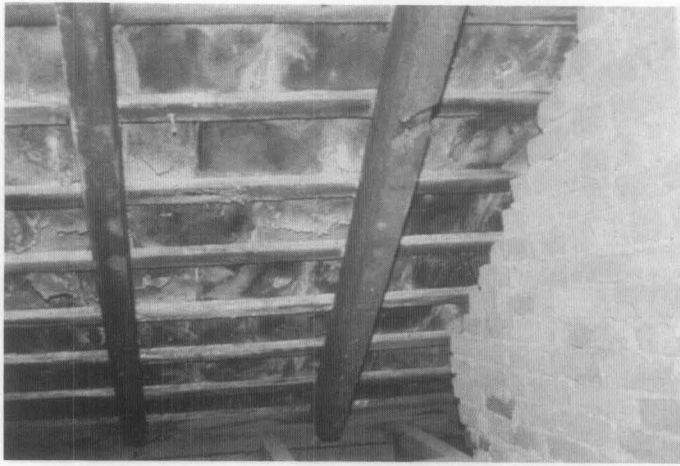
Figure 15. View of the underside of slates laid on open sheathing shows that delamination and flaking is just as bad or worse on the underside of slates as on the exposed surface. This is why most slates cannot be flipped over for reuse.

molecules take up about twice as much volume as calcite molecules, internal stresses result from the reaction, causing the slate to delaminate. This type of deterioration is as prominent on the underside of the roof as on the exposed surface due to the leaching and subsequent concentration of gypsum in this area (Figure 15). Consequently, deteriorated roofing slates typically cannot be flipped over and re-used.

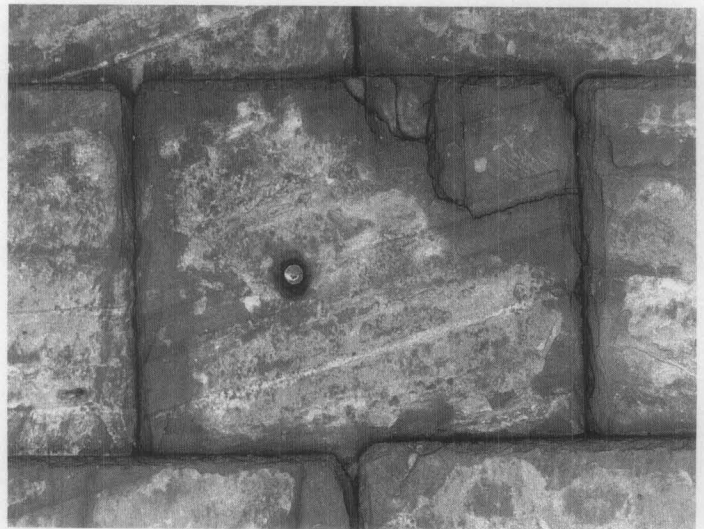
Figure 16. Detail view of a slate which has been punctured by the head of a nail used to secure the slate in the course below. Likely, the nail was not hammered in far enough when originally installed.

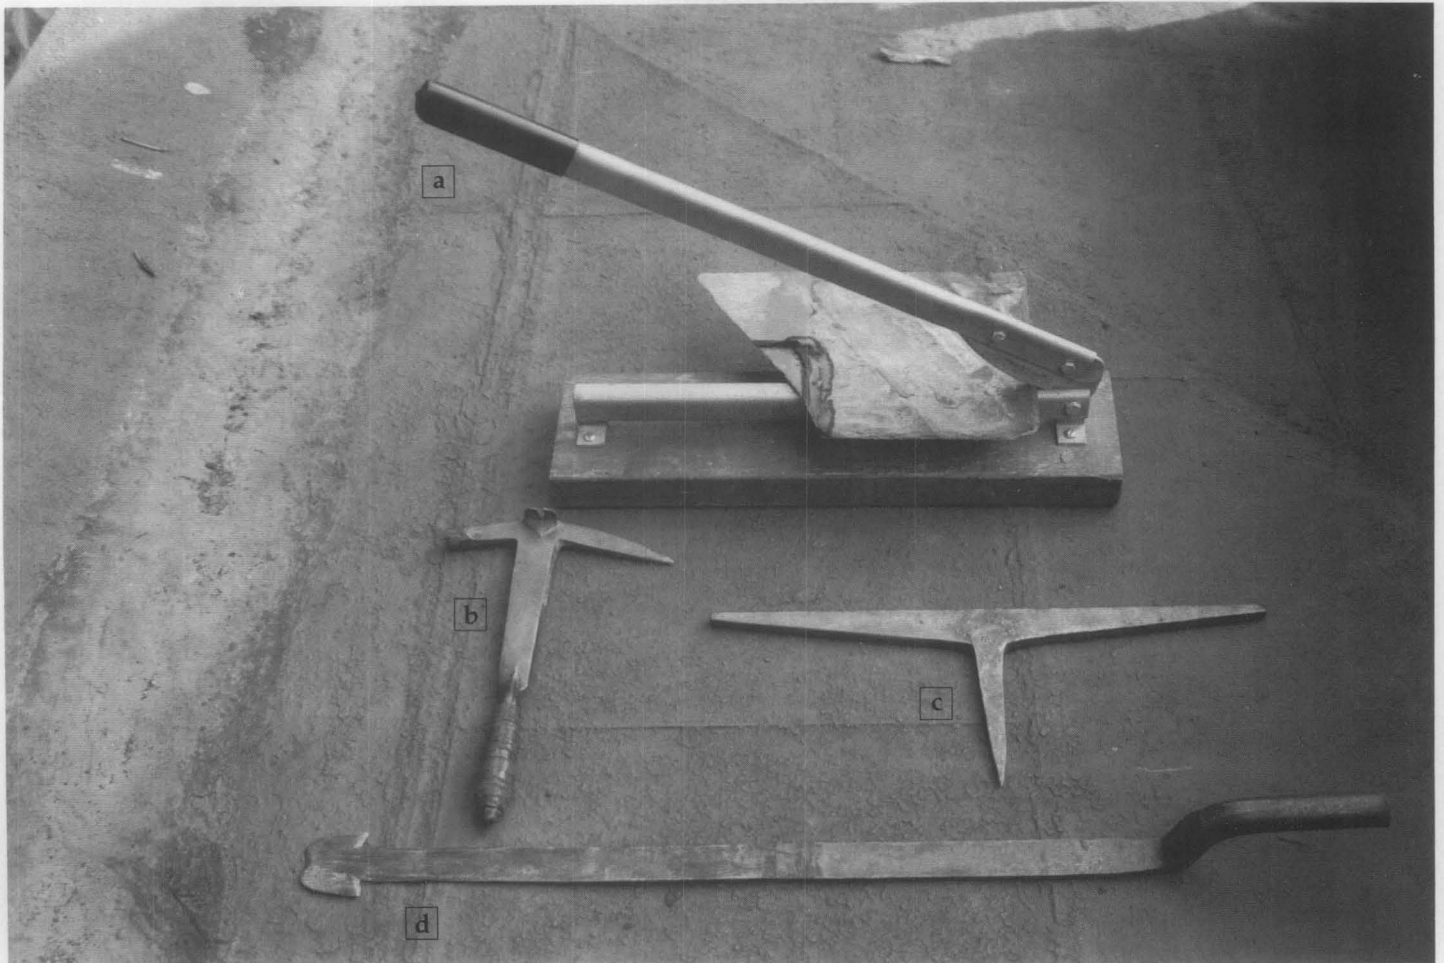
Figure 17. Slater's Tools. The cutter (a) is used to trim slate edges; the slate hammer (b) is used for hammering nails, trimming, cutting and punching holes in slates, and pulling roofing nails; the steak (c) is a T-shaped piece of iron upon which the slater places the edge of a slate to be trimmed; and the ripper (d) is slid under the slates to pull out the nails.

The ability to lay slate properly so as to produce a water-tight and aesthetically pleasing roof requires training, much practice, and the right tools (Figure 17). The

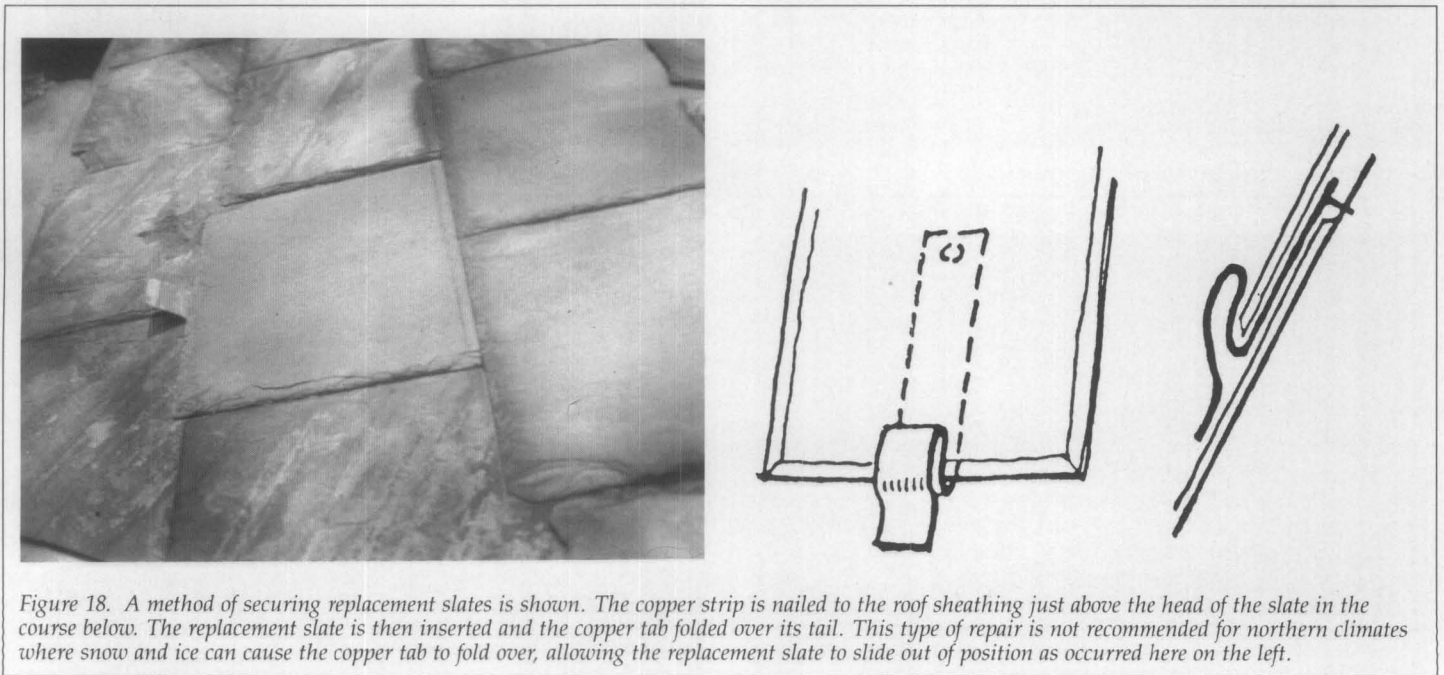
Figure 18. A method of securing replacement slates is shown. The copper strip is nailed to the roof sheathing just above the head of the slate in the course below. The replacement slate is then inserted and the copper tab folded over its tail. This type of repair is not recommended for northern climates where snow and ice can cause the copper tab to fold over, allowing the replacement slate to slide out of position as occurred here on the left.

Broken, cracked, and missing slates should be repaired promptly by an experienced slater in order to prevent water damage to interior finishes, accelerated deterioration of the roof and roof sheathing, and possible structural degradation to framing members (Figures 18 and 19).

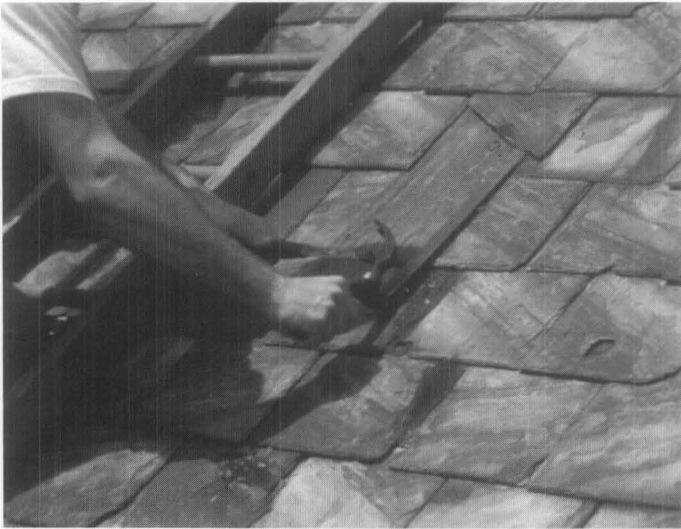
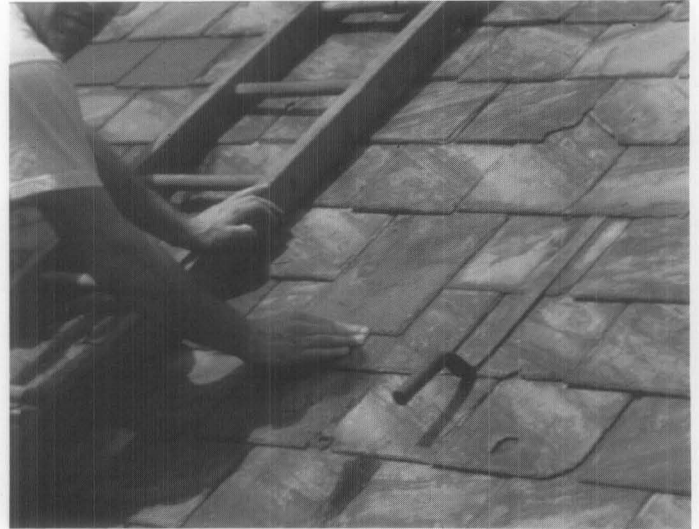
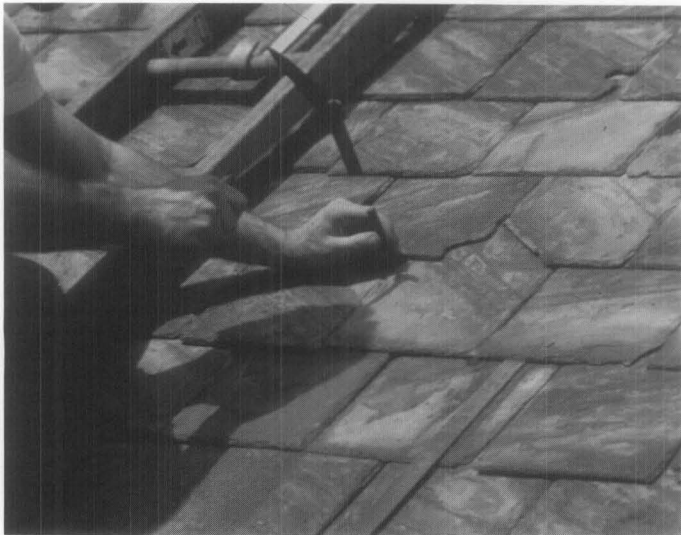
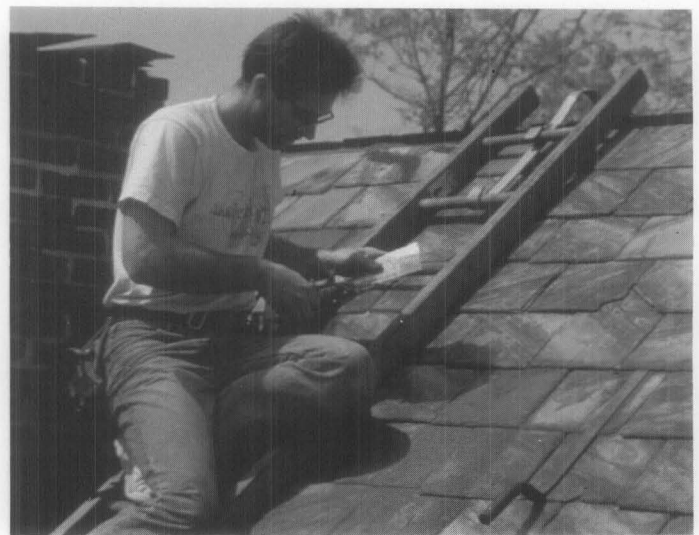
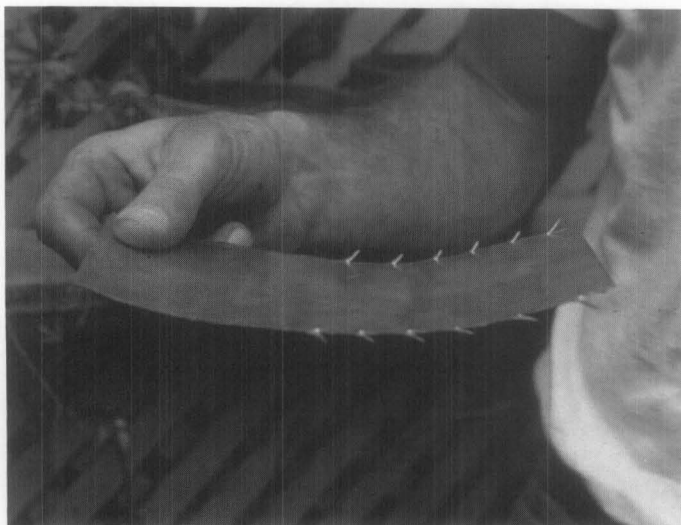
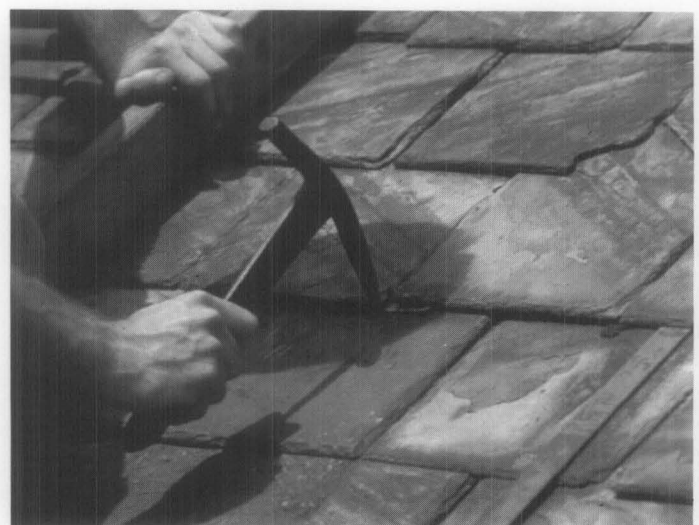
(a) A ripper is used to remove the nails from the deteriorated slate.

(b) A replacement slate is slid into place.

(c) A new slate is secured in place with a copper nail.

(d) A copper bib is formed to protect the newly created nail hole.

(e) The bib is cut along its edges and bent into a concave shape to create a friction fit.

(f) The slate hammer is used to push the bib in place over the nail head.

Figure 19. Above is a repair sequence for replacing a damaged slate.

The damaged slate is first removed by cutting or pulling out its nails with a ripper. If steel cut nails, rather than copper nails, were used in laying the roof, adjacent slates may be inadvertently damaged or displaced in the ripping process, and these, too, will have to be repaired. If the slate does not slide out by itself, the pointed end of the slate hammer can be punched into the slate and the slate dragged out. A new slate, or salvaged slate, which should match the size, shape, texture, and weathered color of the old slate, is then slid into place and held in position by one nail inserted through the vertical joint between the slates in the course above and approximately one inch below the tail of the slate two courses above. To prevent water penetration through the newly created nail hole, a piece of copper with a friction fit, measuring roughly 3" (7.5 cm) in width and 8" (20 cm) in length, is slid lengthwise under the joint between the two slates located directly above the new slate and over the nail. Alternate methods for securing the replacement slate include the use of metal hooks, clips, and straps that are bent over the tail end of the slate. The application of roofing mastic or sealants to damaged slates should *not* be considered a viable repair alternative because these materials, though effective at first, will eventually harden and crack, thereby allowing water to enter (Figure 20). Mastic also makes future repairs more difficult to execute, is unsightly, and, when applied to metal flashings, accelerates their corrosion.

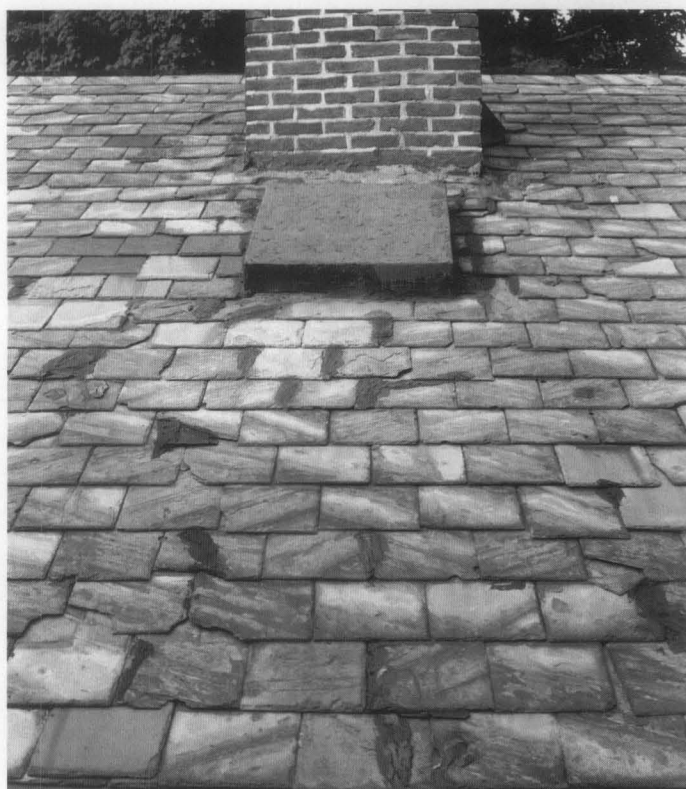
Figure 20. This roof has been poorly repaired numerous times in the past. The installation of mastic to seal out moisture has only exacerbated the problem. A timely repair and good maintenance could have extended the life of this roof.

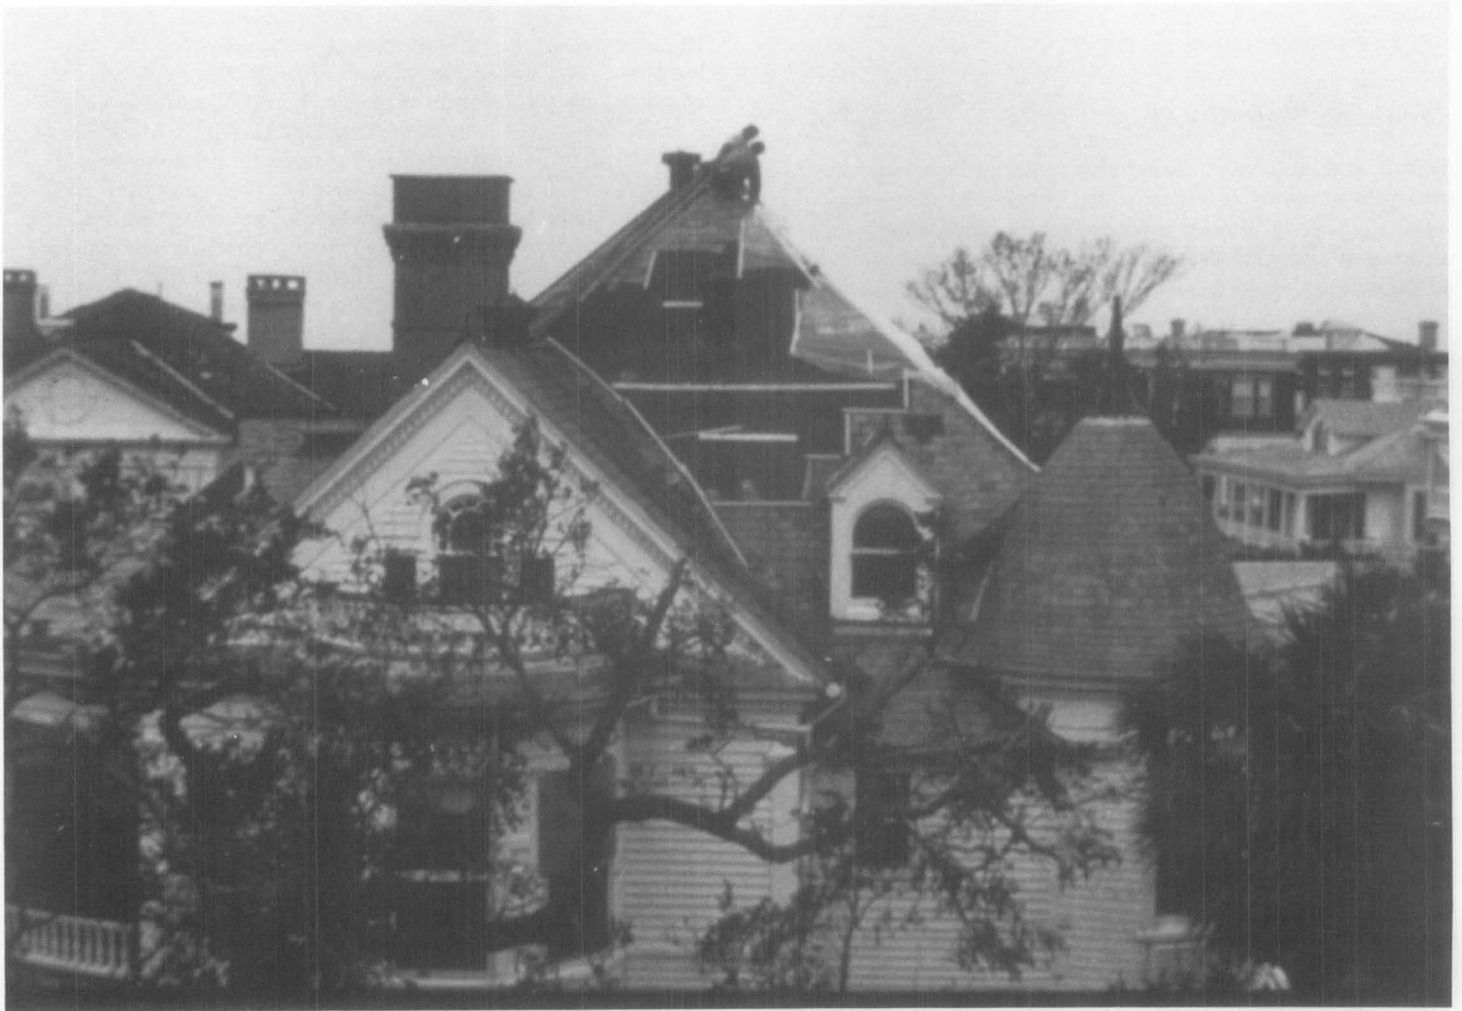
Figure 21. As a result of hurricanes and other disasters, it may be necessary to temporarily stabilize a roof until materials can be obtained and a qualified roofing contractor hired. Heavy roofing felt was stitched into this slate roof to stop moisture penetration until matching slate was obtained for repair. Significant slate roofs should not be stripped off and replaced with asphalt shingles. Photograph courtesy of the National Park Service.

In emergency situations, such as when severe hurricanes or tornadoes blow numerous slates off the roof, a temporary roof covering should be installed immediately after the storm to prevent further water damage to the interior of the building and to permit the drying out process to begin. Heavy gauge plastic and vinyl tarpaulins are often used for this purpose, though they are difficult to secure in place and can be blown off in high winds. Roll roofing, carefully stitched in to areas of the remaining roof, is a somewhat more functional solution that will allow sufficient time to document the existing roof conditions, plan repairs, and order materials (Figure 21).

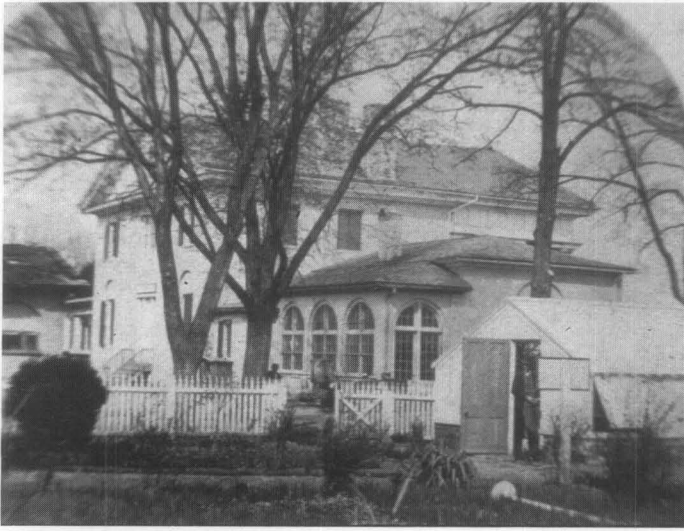
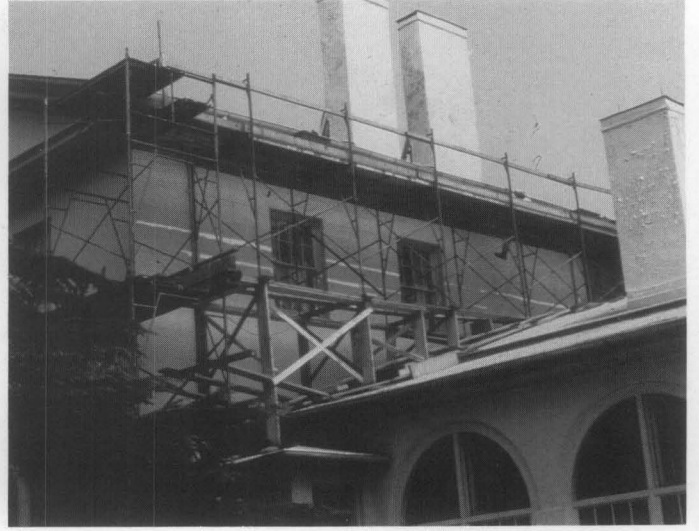
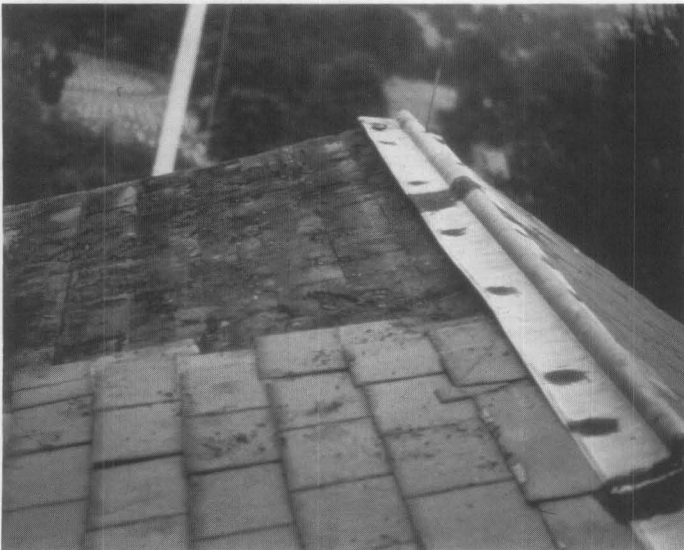
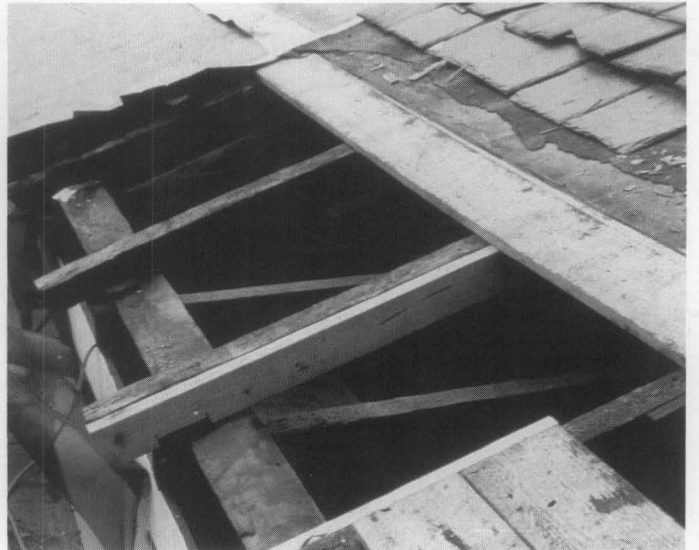
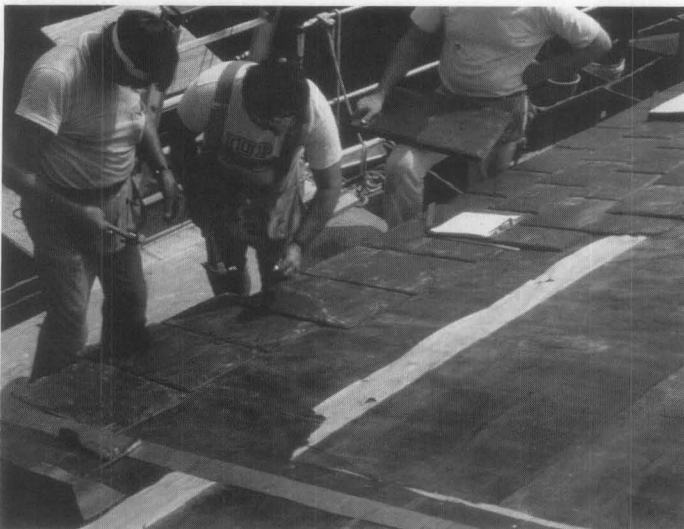
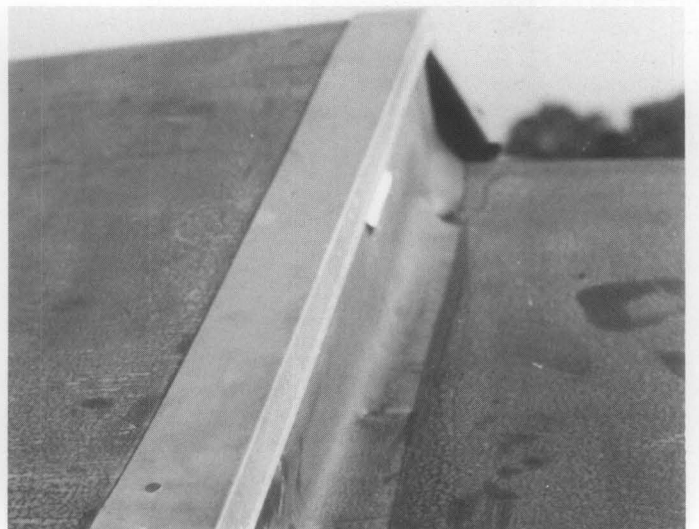
(a) Historic documentation was necessary to determine the historic configuration.

(b) Scaffolding was installed early to document existing conditions to determine extent of work.

(c) Slate was removed in sections to avoid stress on timber framing.

(d) Deteriorated sheathing was replaced and rafter tails were reinforced.

(e) Roofing felt was installed over decking; a rubberized membrane was used selectively at the eaves and under some flashing.

(f) Lead coated copper flashing was installed throughout. Seen is the offset between the portico roof and the main roof in progress.

Figure 22. Installing a new roof involves more than just slate. Above is a sequence of views of the roof replacement at Arlington House. Photographs courtesy of the National Park Service. (Sequence continued on page 14.)

If repair is not possible and a new slate roof must be installed, it is important to remember that more than just the replacement of the slate is involved (Figure 22). The old slate should be removed to prevent overloading of the roof timbers. Stripping should be done in sections, with felt installed, to avoid exposing the entire sub-roof to the weather. In the process, rotted wood sheathing should be replaced and the roof timbers checked for signs of stress, including deflection, cracking, and twisting. If such conditions are found, a structural engineer experienced in working with older buildings should be consulted. Other repairs, such as chimney repointing, which may require access to the roof should be completed before the new roof is put on.

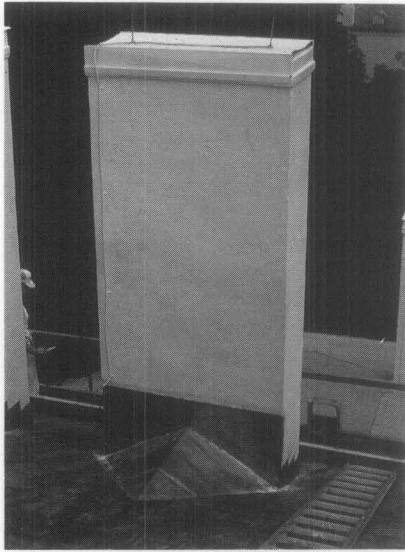
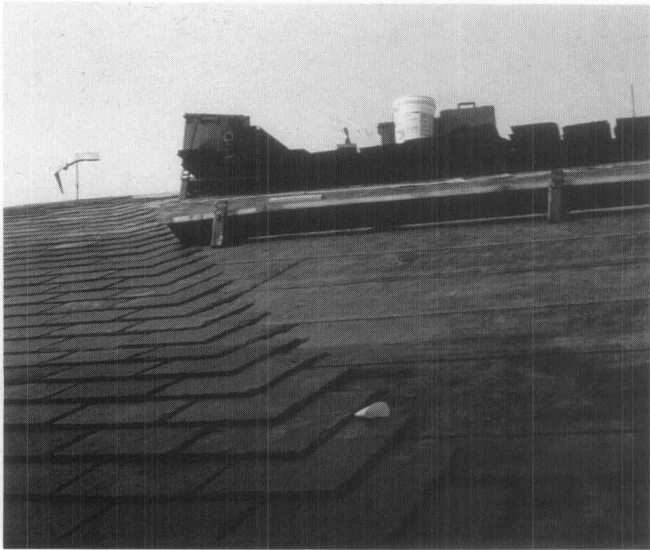
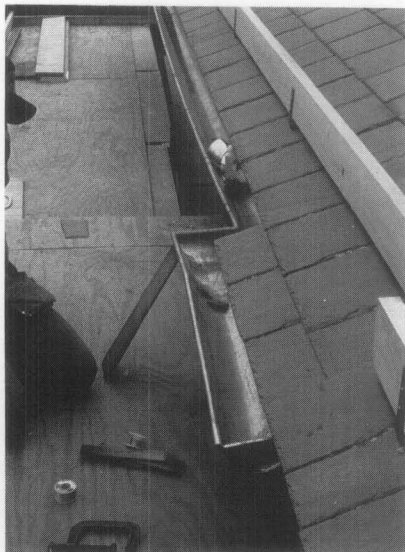
(g) Masonry chimneys were repaired and metal crickets were fabricated at the chimneys.

(h) This installation pattern allows the slates to be laid in courses leaving a temporary path of travel to avoid stepping on installed slates.

(i) Although the gutters and snow boards were the last elements installed, their support brackets were installed as the slates were laid.

◀ Continuation of the roof repair sequence of Arlington House from page 13.

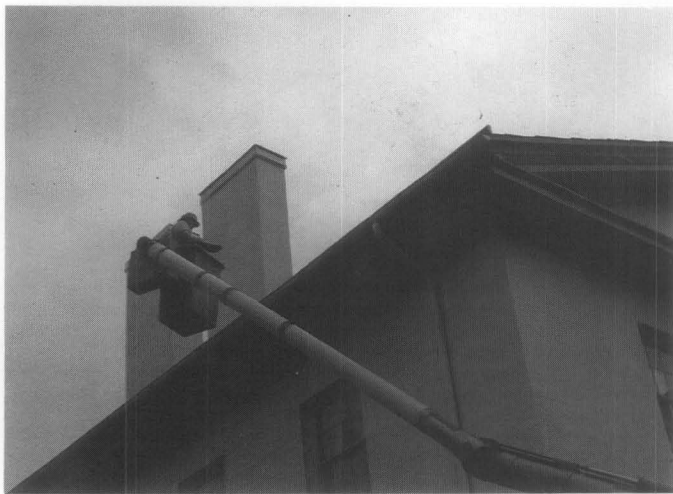
Figure 23. Slate roofs should not be walked on if at all possible. For large projects, lifts can be used to inspect roofs periodically to assess maintenance needs. Photograph courtesy of the National Park Service.
