29 PRESERVATION BRIEFS

The Repair, Replacement, and Maintenance of Historic Slate Roofs

Jeffrey S. Levine

U.S. Department of the Interior
National Park Service
Cultural Resources
Heritage Preservation Services

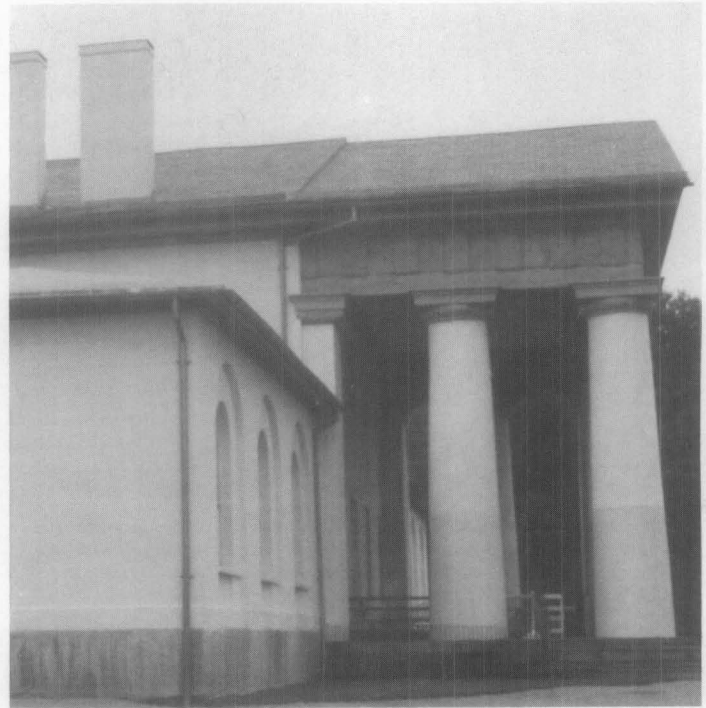
Figure 24. Although slate replacement roofs are expensive, the superiority of materials and craftsmanship will give years of continued service. If amortized over the life of the roof, the replacement cost can be very reasonable. Photograph courtesy of the National Park Service.

Slate roofs are a critical design feature of many historic buildings that cannot be duplicated using substitute materials (Figure 24). Slate roofs can, and should be, maintained and repaired to effectively extend their serviceable lives. When replacement is necessary, details contributing to the appearance of the roof should be retained. High quality slate is still available from reputable quarries and, while a significant investment, can be a cost effective solution over the long term.
