The ravaging effects of hail, winds, or falling debris on a slate roof are often overtly apparent, yet sometime the effects of the events come to life in later months.

Replacing a Slate Roof

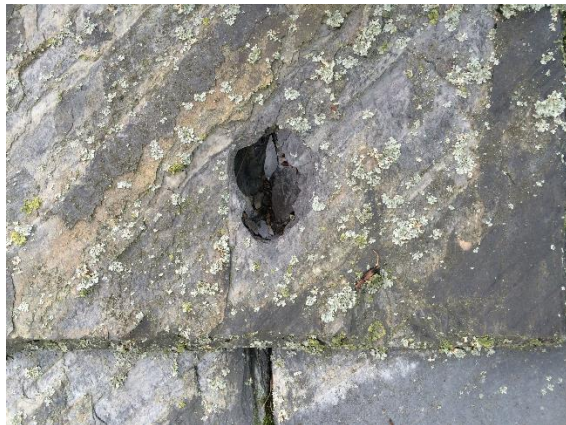
After a hail storm definite round penetrations in the slate may be seen. The stone may break on the edges or it may even develop as an interior hole as seen in this photo or the other photos from this roof.

All these slates need to be replaced as they are now retaining moisture, saturating not only the slate but the underlining roof deck.
