Concrete Tile replaced with Natural Slate

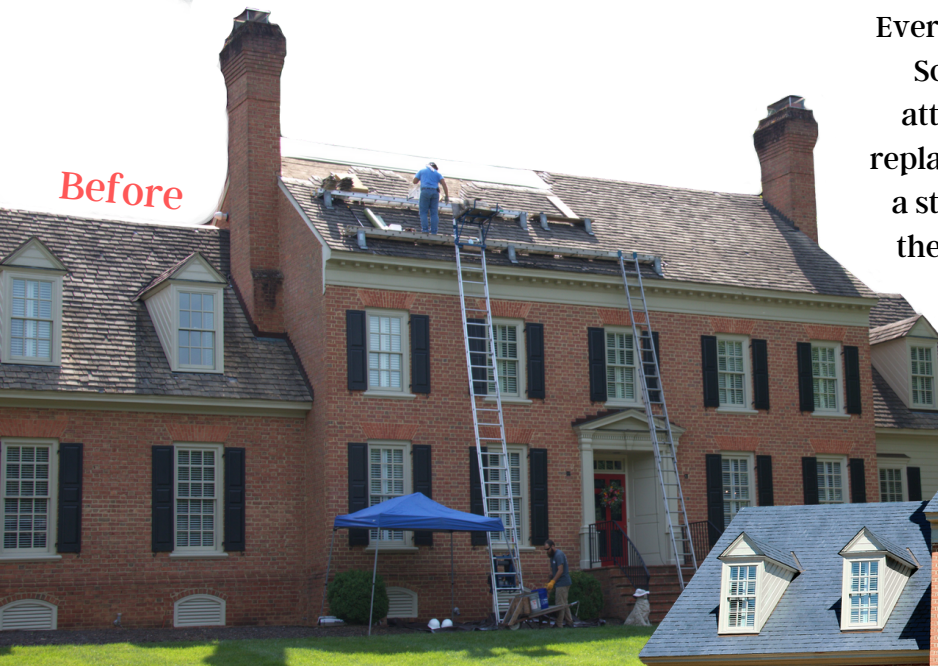
Before

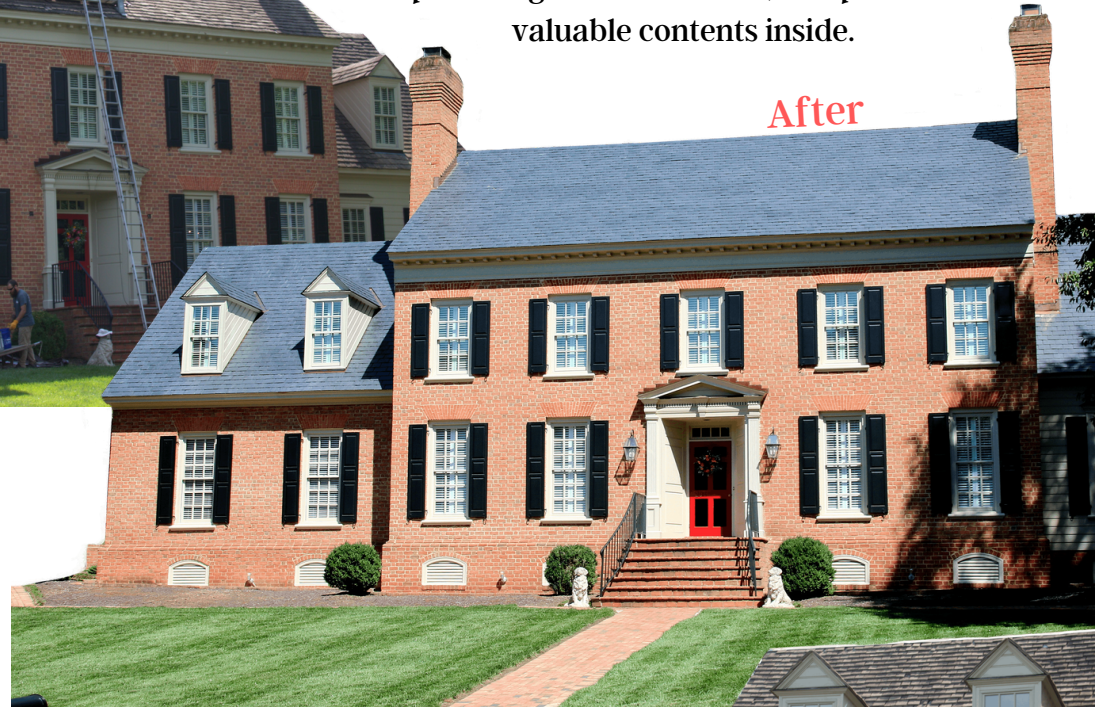
After

In this case study the Hendricks tile, a concrete tile reinforced with steel, was at the end of its life. The homeowner wanted a hard roof that could offer protection, beauty, and durability. A slate specialist was contracted to install the 16 x Random x 1/4-3/8" unfading black Spanish slate. As the color of the roof changed from a brown taupe to a rich blue black, and the whole house was given new life. The weight of the slate was similar to that of the tile, so structural enforcement was not necessary. This house will now be protected for the next 100 plus years. The roof isn't only a protector but also a 1/3 of the visual interest of a structure. Slate adds visual natural interest with a uniformity in color yet the natural unmistakable surface texture of a natural stone. We build our homes with elements of beauty, longevity, and integrity, let's make sure that we install our roofs with these attributes as well.

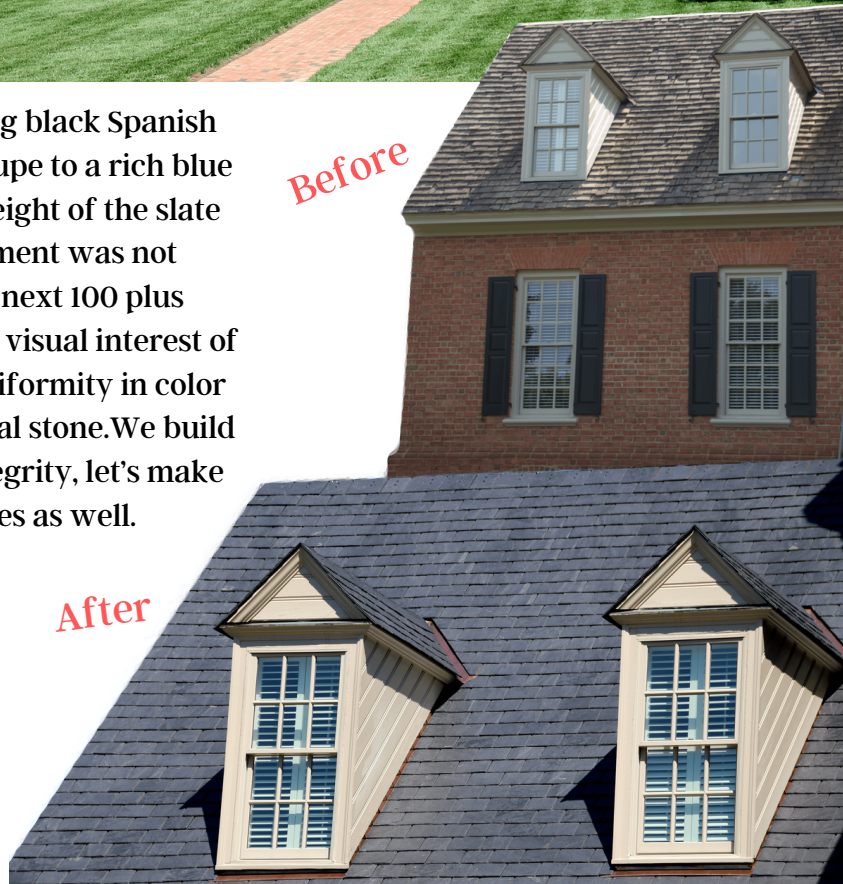
Before

After
