## Copper and Natural Slate Roofing

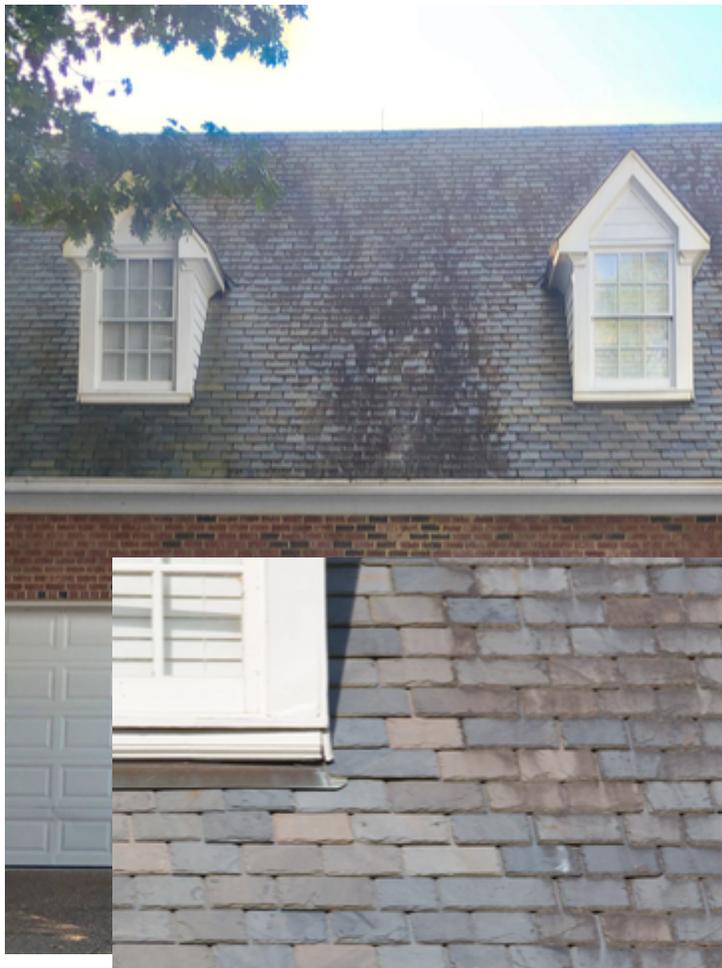
The area of slate below the copper flashing is free from mold, yet the area above copper has been **discolored by the environmental build up.**

Even with its density and non-porous surface, slate may develop areas of black mold or environmental build-up. These spots usually occur in north facing surfaces where water may not dry out as fast. The natural sluffing of copper and the intrinsic antimicrobial properties prevent the growth of fungi, bacteria, molds, and viruses while cleaning the natural slate and preventing build up. As the slate is installed, if copper flashing may be installed over the natural slate with 1/2" exposure the likelihood of environmental build-up may be greatly reduced.
